Barton under Needwood Parish Council
Barton Flood Risk Group

Barton Brook - Surface water flooding 16-02-20.
 Brookside/Wales Lane

Plan BB-02 Drawn E Sharkey - 02-03-20

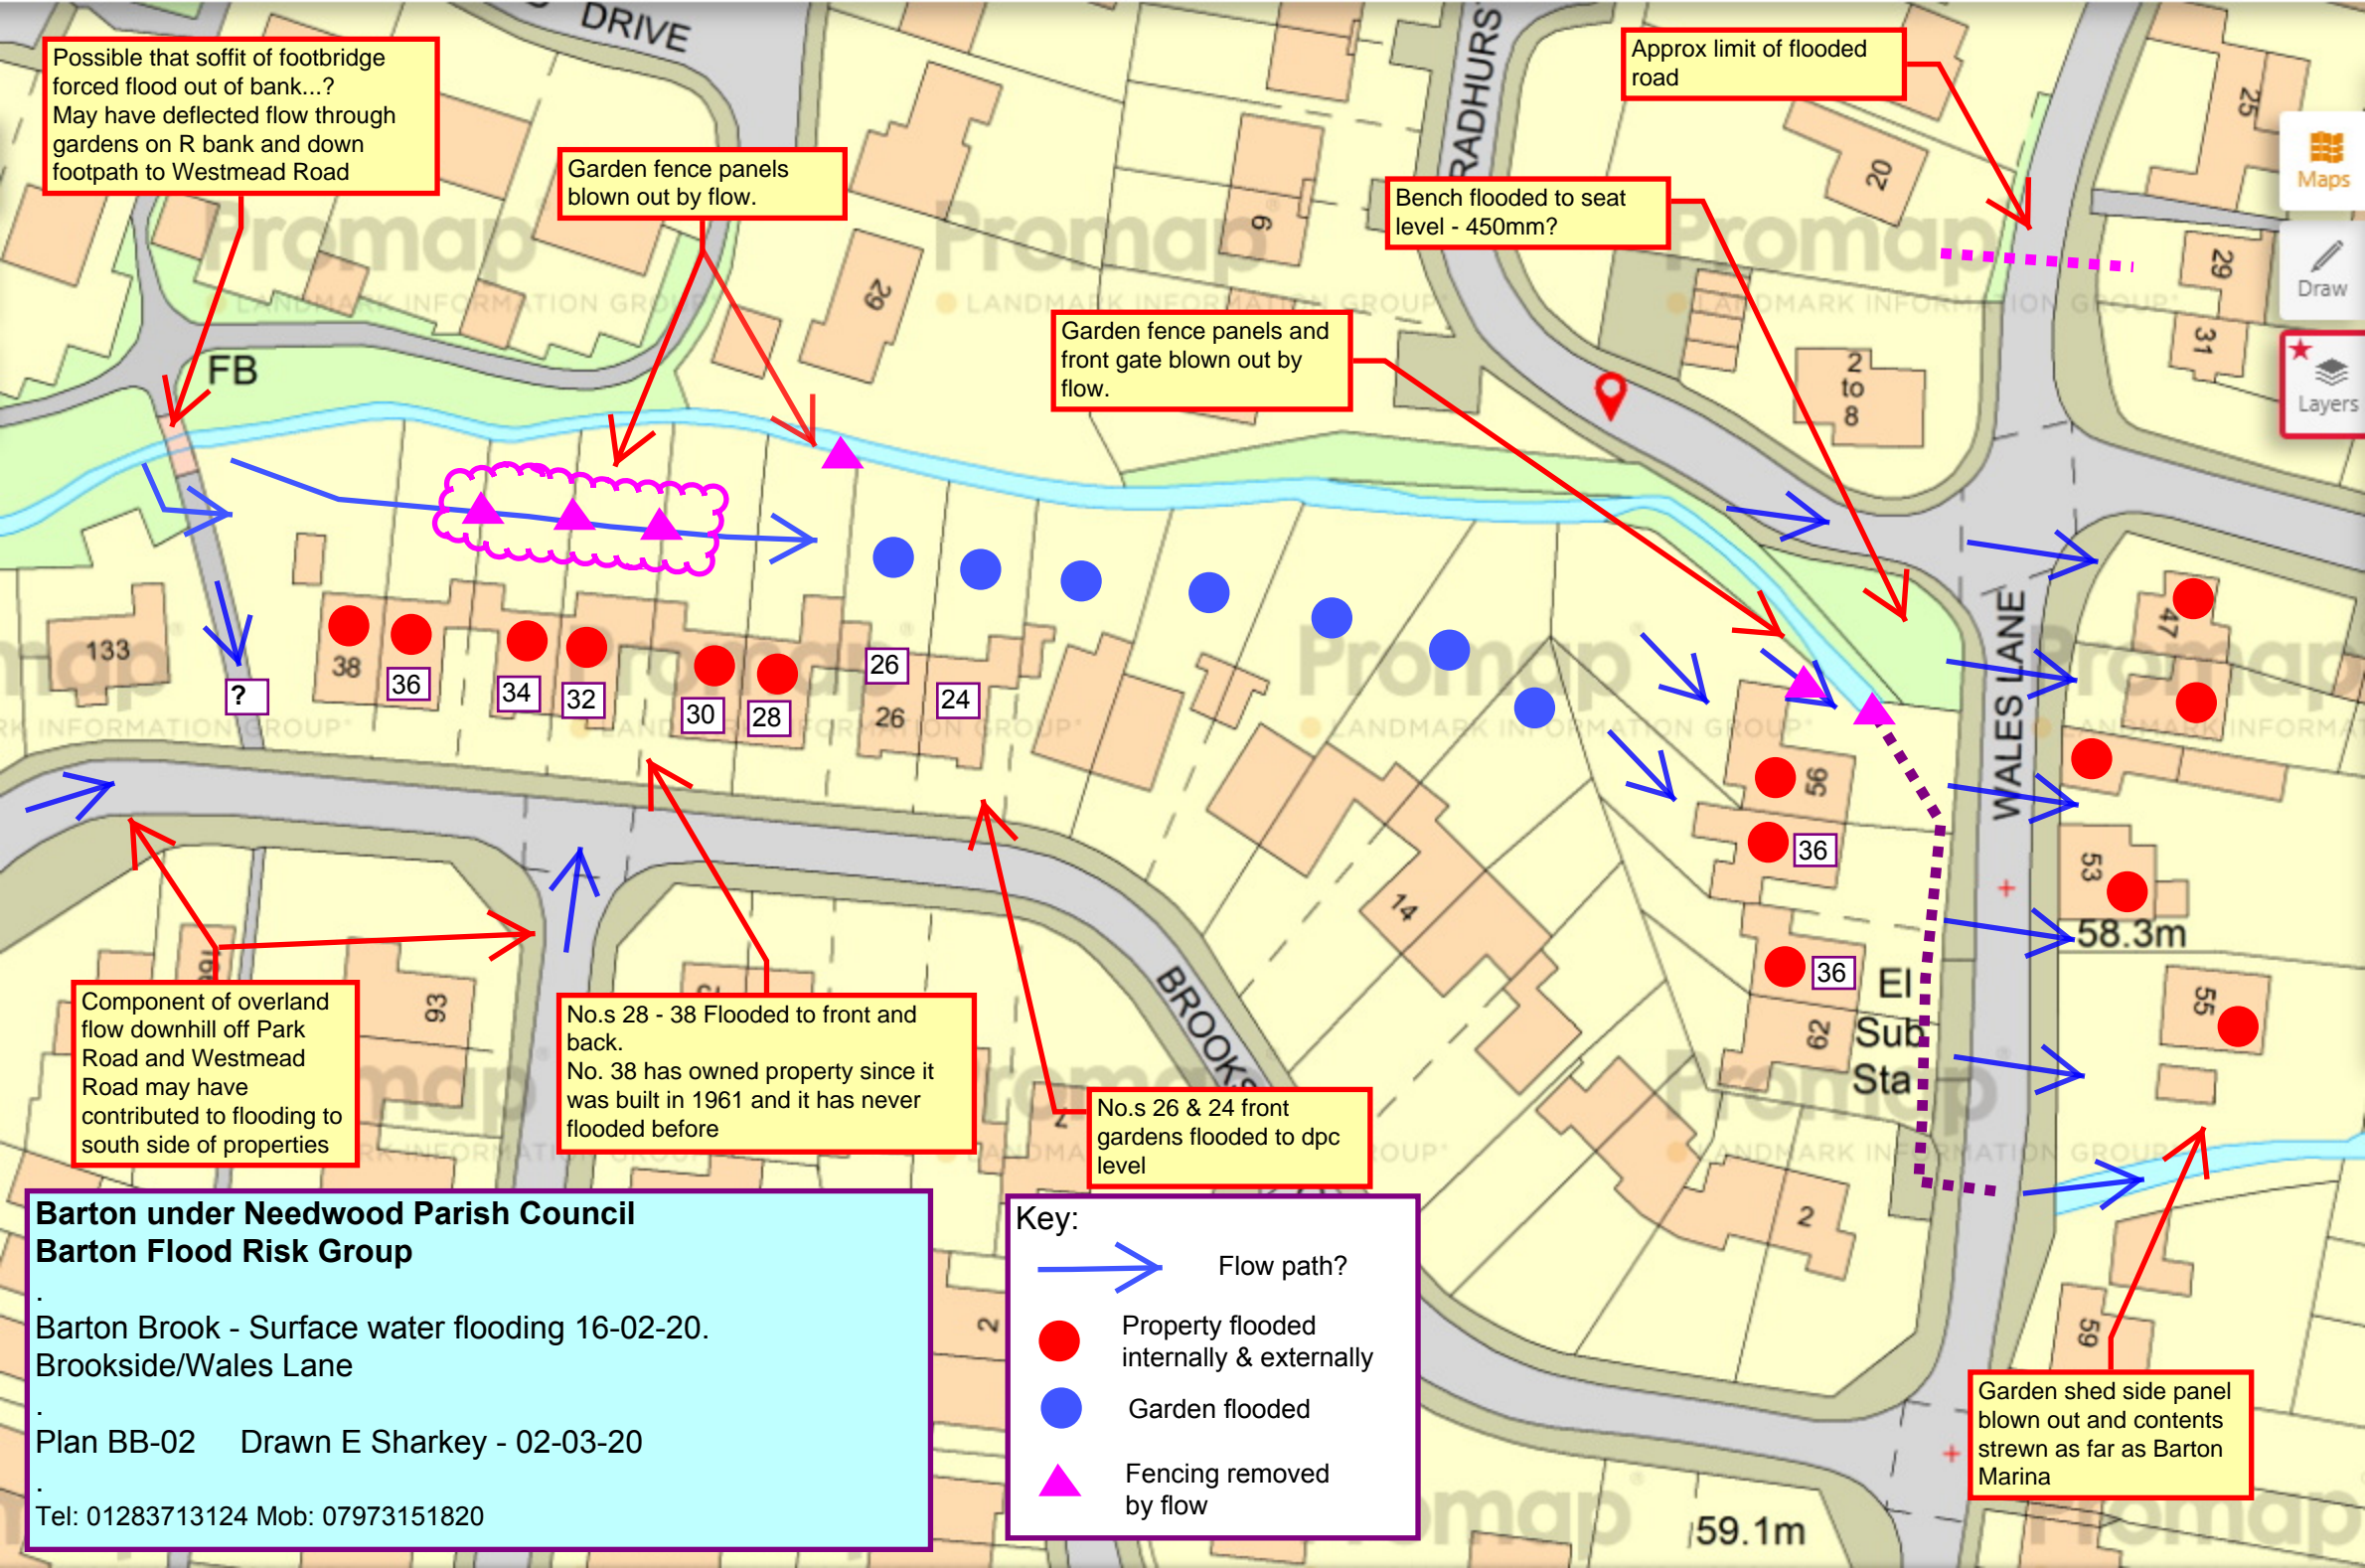
Possible that soffit of footbridge forced flood out of bank...?
 May have deflected flow through gardens on R bank and down footpath to Westmead Road

Garden fence panels blown out by flow.

Bench flooded to seat level - 450mm?

Approx limit of flooded road

Garden fence panels and front gate blown out by flow.

Component of overland flow downhill off Park Road and Westmead Road may have contributed to flooding to south side of properties

No.s 28 - 38 Flooded to front and back.
 No. 38 has owned property since it was built in 1961 and it has never flooded before

No.s 26 & 24 front gardens flooded to dpc level

Garden shed side panel blown out and contents strewn as far as Barton Marina
